Bamburgh

Budle Deserted Medieval Village

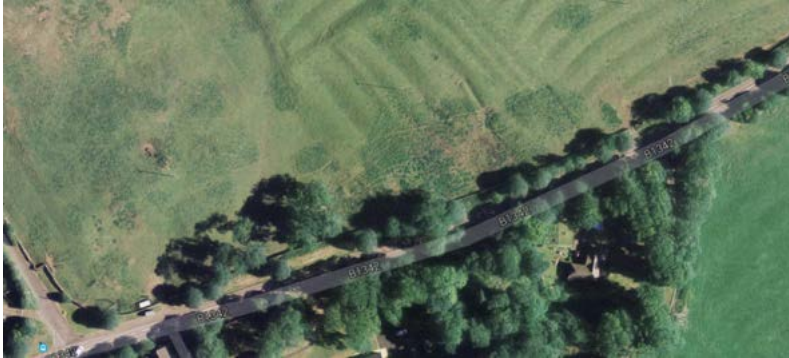
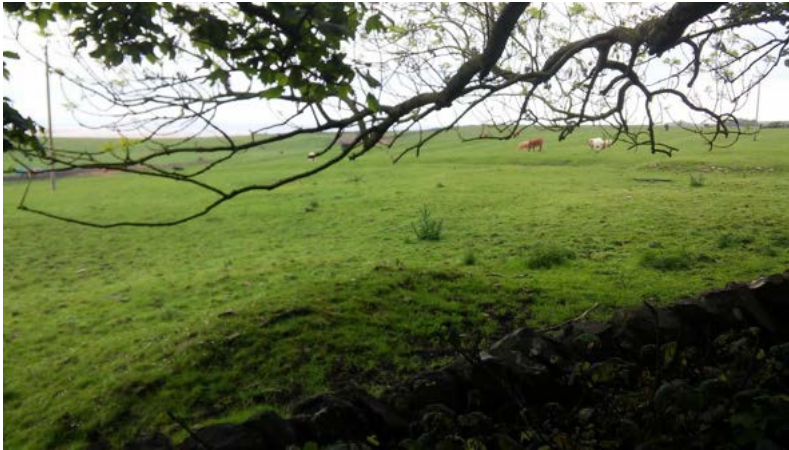
Description: Documentary references from 1242, through to 1861. 19th century earthworks and extensive medieval ridge and furrow in the field opposite farmhouse (post-medieval).

Notes: Earthworks and some evidence of walls apparent from ground level. Various shapes visible in aerial photography taken from Google Earth in 2016.

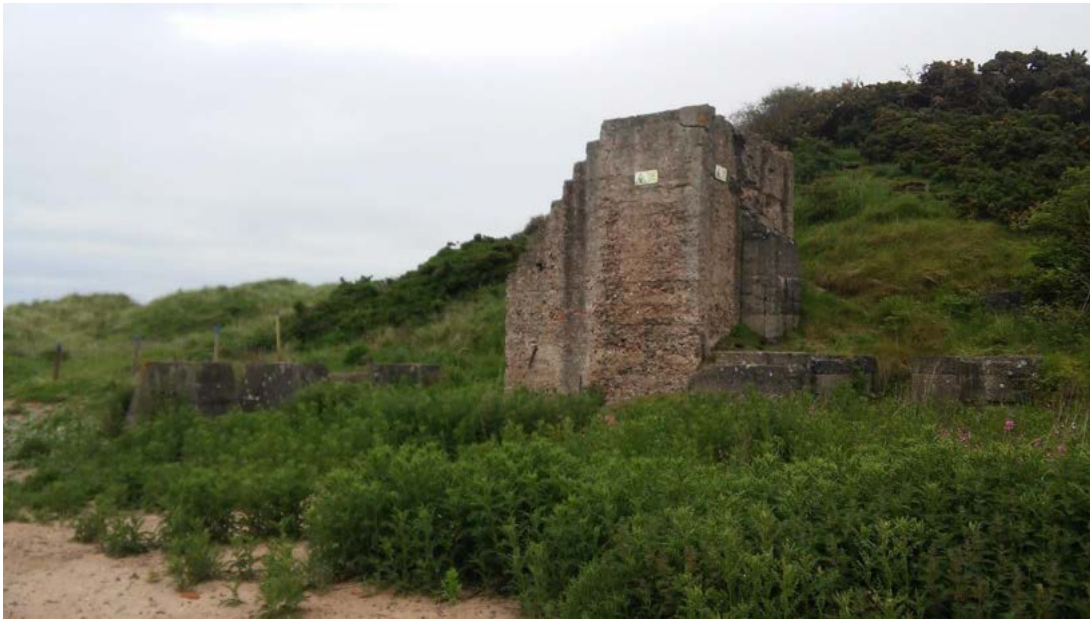
Budle Bay Stone Crushing Plant

Description: The remains of crushers and screens that processed stone transported from a quarry at Kittling Hill between c1911-1915 for a firms called Brands. Light railway, operating three locomotives, connected quarry to crushing plant. The crushed stone was then transported from the nearby old grain jetty to Kings Lynn, Boston and Whitstable, according to a March 1913 article in *The Berwick Advertiser*.

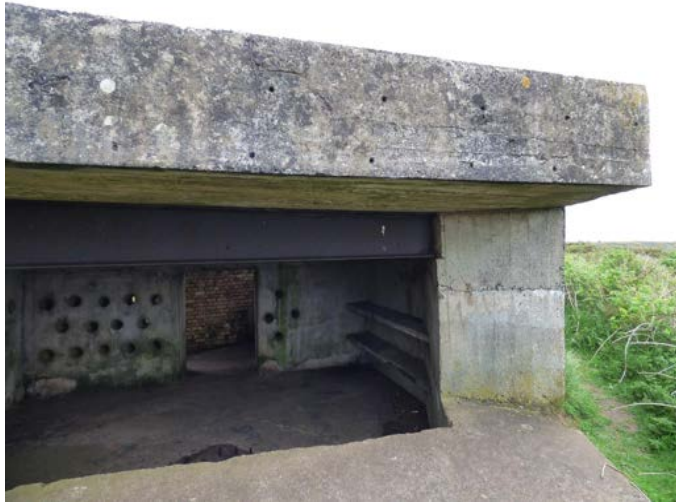
Newtown Gun Emplacement

Description: WWII gun emplacement of concrete construction with brick entrance. The building comprises of the emplacement where the bolt fixings of the gun are still visible in the floor. Gun opening faces N, covering the Bay. 10cm terracotta pipes built into the rear and side of the chamber for smoke exhaust. Concrete shelves present on the W interior wall. There is an offset brickwork blast door and a small storage area (magazine?) to the S side. The entrance blast wall is in garden wall bond brickwork and sand cement rendered on the outside. It also has an opening at high level as it joins the store concrete roof – possibly for further smoke exhaust. Very similar in design to Scremerston Gun Emplacement which has a slightly different gun opening and rear entrance configuration as well as no shelves and fewer exhaust pipes. Structure is well-preserved, set within stable dune grass area.

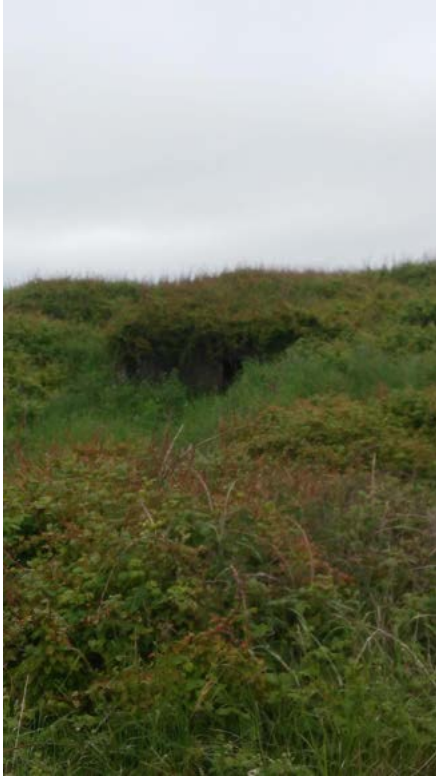
Harkness Rocks Pillbox

Description: WWII pillbox that includes an anti-tank/machine gun emplacement and embrasure. Located within the dune grass of the area.

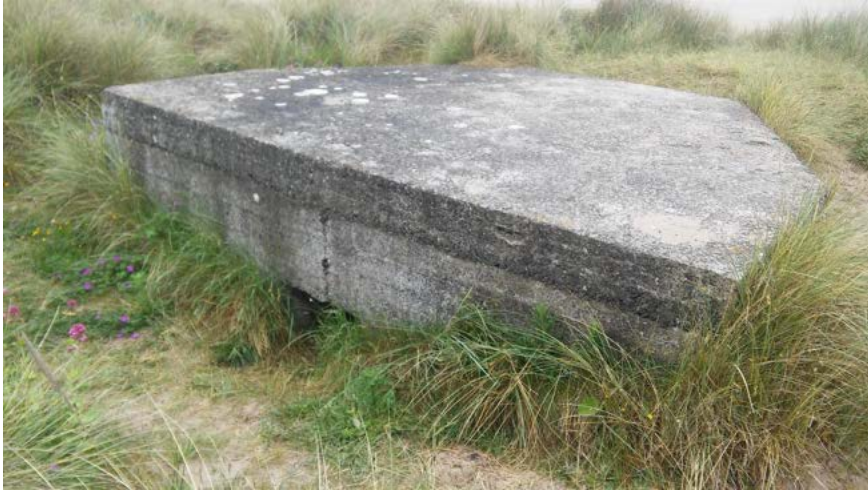
D-Shaped Pillbox

Description: Exceptionally well-preserved, d-shaped WWII pillbox located on a defensive knoll within the dune grass to the N of Bamburgh village.

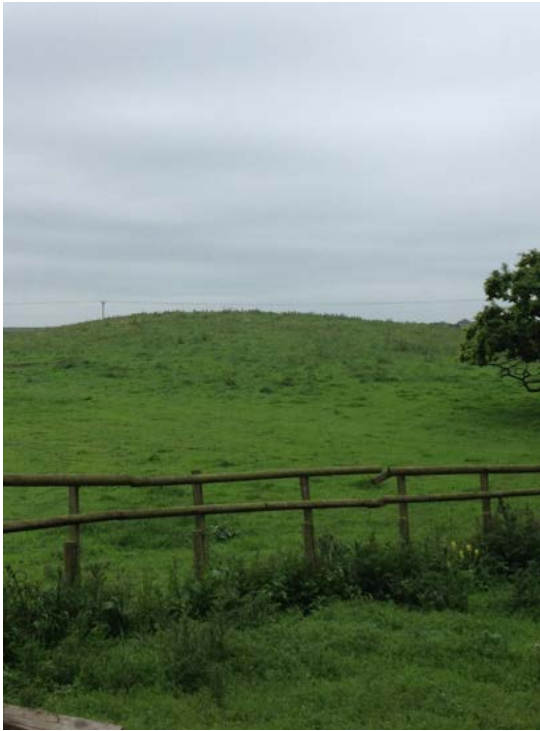
Mound/Hillock

Description: Large mound, 65m in diameter, rising 9.5 meters above the surrounding landscape, easily visible from Links Road. which might well be a natural hillock. Small excavations in 1928-1929 suggested it to be an artificial structure, overlain by some 6ft of blown sand. A medieval sherd and part of a handle were the only finds. The NE edge of the mound seems to be cut by linear earthwork which may relate to a track of path seen on the first edition Ordnance Survey map. Geophysical survey in 2004 revealed a number of anomalies suggestive of pits, buildings and a ditch.

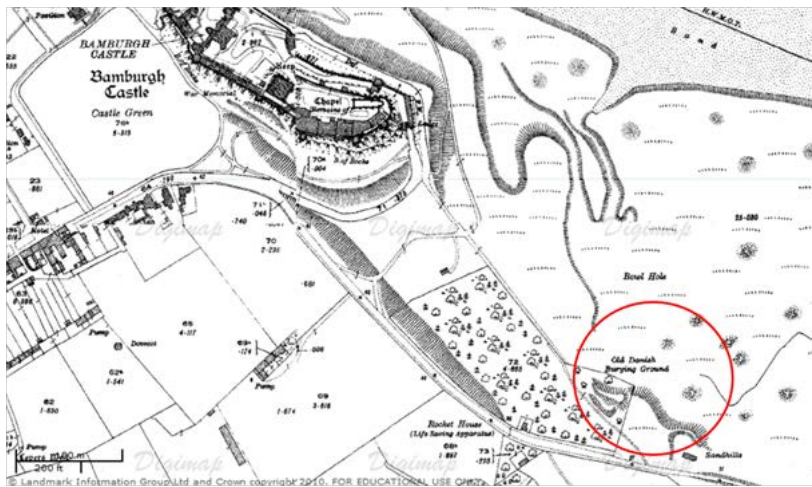
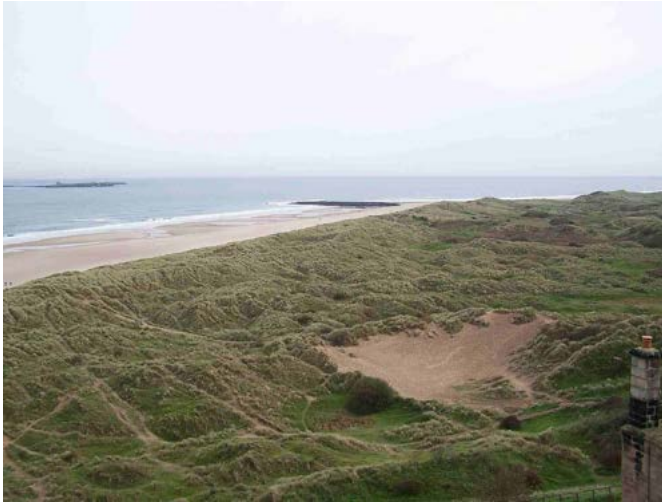
Bowl Hole

Description: This site is a large, natural hole in the sand dunes with a heavy surface scatter of fragmentary bone, presently covered with turf to protect the archaeological remains. In the early 19th century blowing away of sand after a storm revealed a number of graves. Initial excavations c1894 revealed interments disposed at length in rough cists at a shallow depth,

including two crouched burials, without grave goods, and the remains of an infant lying in a circle of boulders at a greater depth.

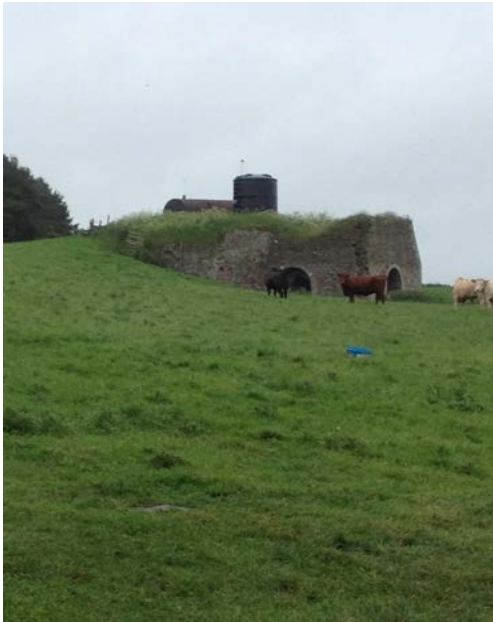
Burton Quarry Limekiln

Description: Truncated kiln and collapsed pot. Three draw arches with one eye per arch.

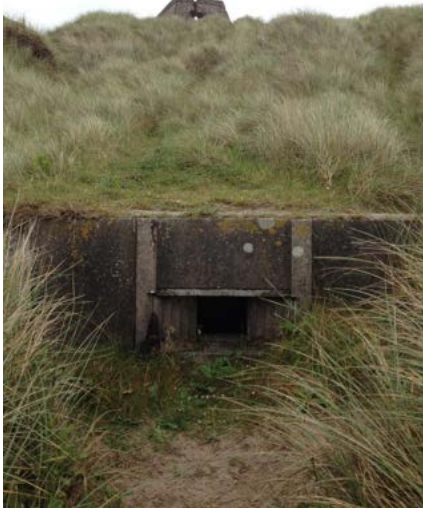
Greenhill Rocks Pillbox

Description: Concrete WWII structure in good condition, sited at the top of dunes.

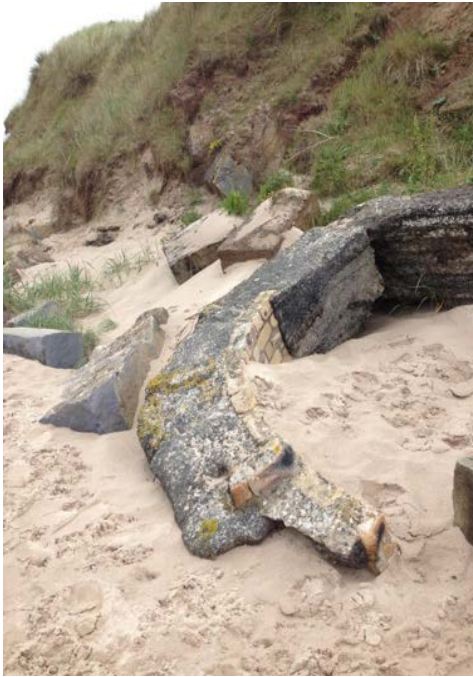
Greenhill Links Pillbox

Description: Concrete and sandbag WWII pillbox that collapsed onto beach sometime before 1993.

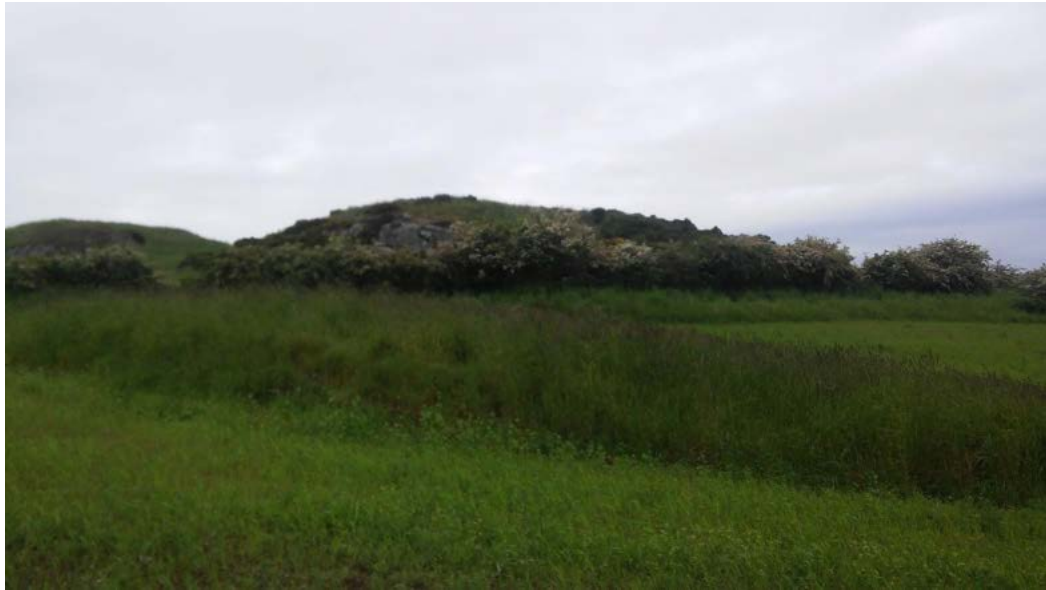
Royal Observer Corps Monitoring Post

Description: Subterranean monitoring post, mid 20th c., WWII? Noted as a particularly good surviving example.

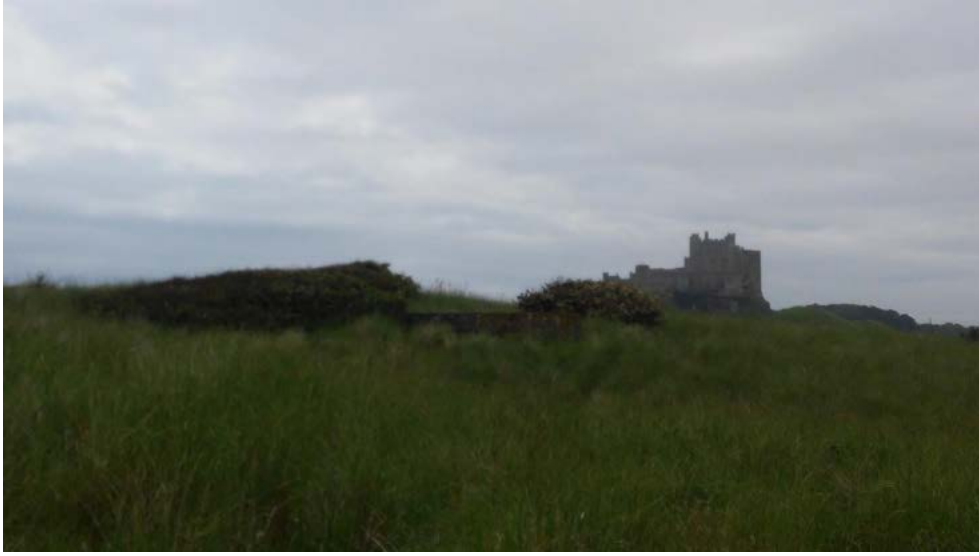
Lozenge Pillbox

Description: Lozenge shaped coastal WWII pillbox.

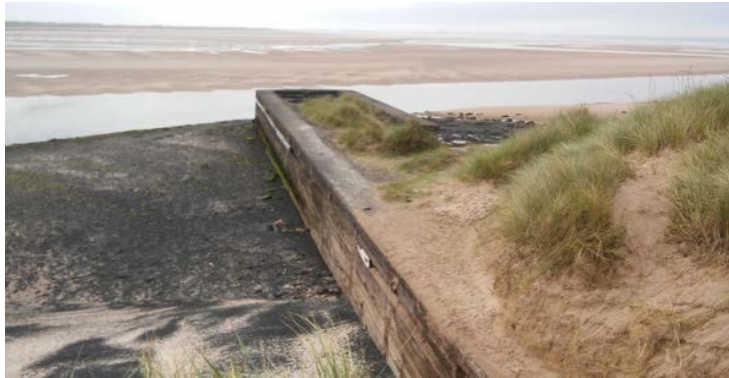
Pier in Budle Bay

Description: Pier shown on first and second edition OS maps (c1860 and c1897). Two visible phases of construction. First was a smaller structure, lower, narrower and shorter, made of large, crudely dressed blocks of whinstone (measuring up to 0.5m x 0.5m x 1m each). This phase could be related to the nearby granary, known to be inland of the pier 1860. Pier could have been as much as 200 years old at this time, though more likely 10-100 years. Second phase completely clads the first phase in cast concrete, reinforced in some areas with wooden beams, both on the top surface and on the sites where evidence of staking strips are clearly visible. There was also a substantial sunken pit at the seaward end, spanned by wooden beams, likely serving some mechanical function when the pier was used for loading crushed stone from the nearby crushing plant in the early 20th century. Pier likely adapted to accommodate this new use which meant larger ships would be docked there and required the pier to take the weight of machinery to handle the crushed stone. The second phase of construction is as much as 2m wider, 0.3m taller and 3-5m longer than the first phase, which is only visible where the second phase has been damaged by erosion.

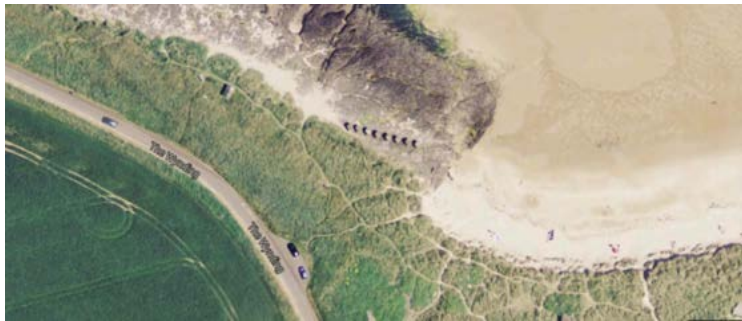
Harkness Rocks Tank Traps

Description: WWII concrete cubes, or tank traps on the shoreline at Harkness Rocks, two have been painted red and white to resemble dice and c2016 another two were painted to resemble rubix cubes. Some cubes not in situ?

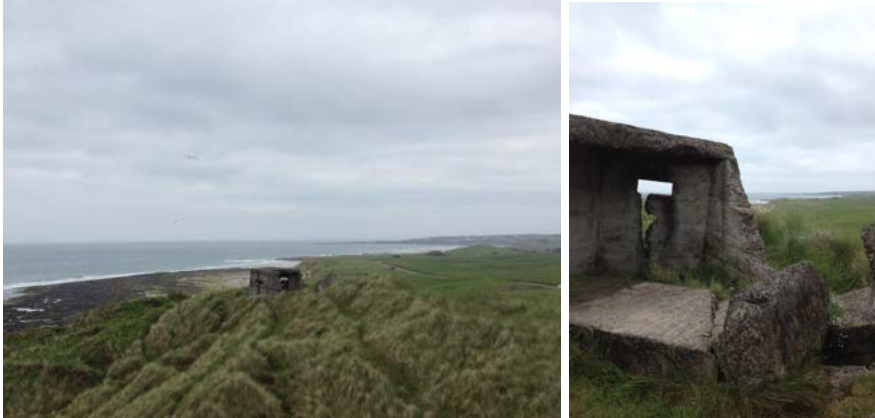
Greenhill Links Pillbox Ruins

Description: Ruins of a WWII pillbox, largely still standing, apparently deliberately destroyed.

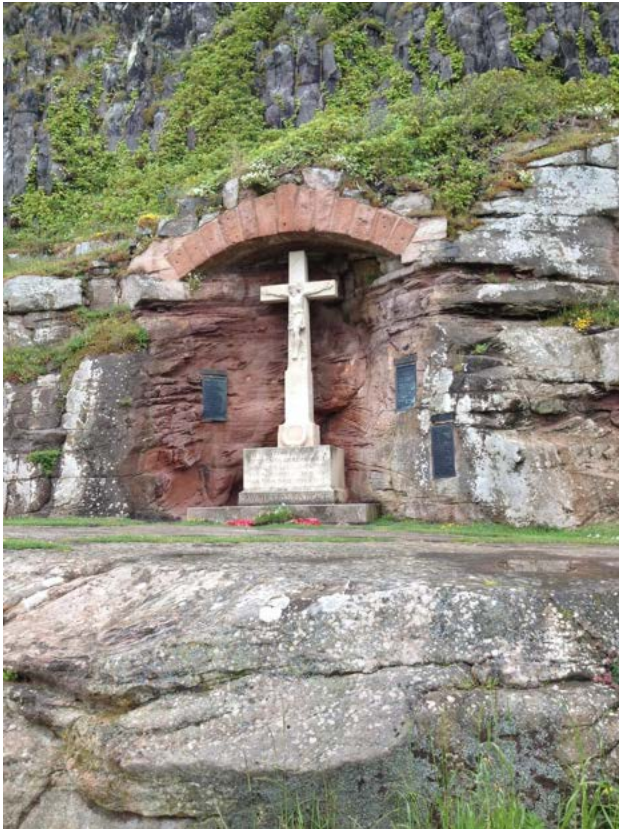
Bamburgh War Memorial

Description: Located within a carved niche at the foot of the crag on which Bamburgh Castle stands. The memorial is in the form of a Portland stone cross with Christ figure mounted on a square plinth. Within the niche there are also a number of bronze plaques which record the names of the fallen. The memorial was designed by Messrs Hicks and Charewood and the sculpture was by a Mr Milburn. The memorial was unveiled by Lord Armstrong on the 15th May 1921. The main dedication is on the plinth of the memorial and reads: 'To the glorious memory / of the men of Bamburgh / who gave their lives for / their country in the wars / 1914-1919 and 1939-1945 / May they rest in peace'.

An application was made in 2009 to the War Memorials Trust for funding to clean the monument, remove biological deposits, consolidate friable surfaces and make mortar repairs.

The inscription of the bottom of the shaft was faded and illegible so it was agreed that a new piece of stone with the original inscription ('Greater love hath no man than this') be pieced in. The bronze plaques in the niche were also cleaned, repatinated and covered in a protective microcrystalline wax.
